**Flood Control Project Maintenance  
Levee Inspections**  
**LMA District Cover Sheet**  
**Spring 2019 Levee Inspection Results**

**Reclamation District No. 0563 Tyler Island**

**Spring 2019 Levee Inspection Results**

Waterway			Bank	Unit Miles
Unit No. 01 Georgiana Slough (Tyler Island)			Left	12.11
	Spring (March - May)	Summer (June - August)	(September - November) Fall	Winter (December - February)
Unit Maintenance Rating (Fall Only)				
Date of Inspection	4/5/2019 - 4/5/2019			
DWR Inspector	David Julian			
Accompanied By	Steve Mello RD 563

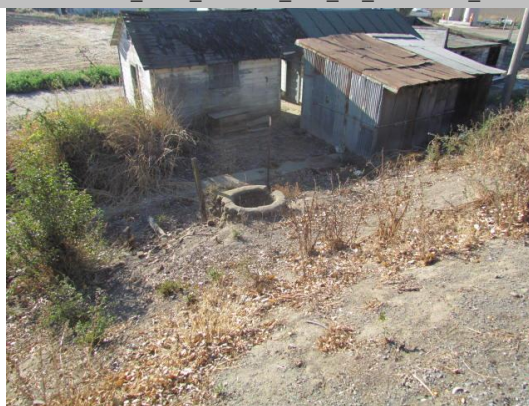
Photo 1 of 3 : SP\_2019\_RD0563\_210\_10\_20190311\_00006.jpg

LM Start	0.15	Rating **	M	Issue No.	10
LM End	0.15	Issue Type +	En	Location *	LS
Category	Earthen Levee			GPS Latitude/Longitude	
				Start	End
Item	Encroachments			38.233572 °	38.233572 °
				-121.519083 °	-121.519083 °
DWR ID	DWR_RD0563_01_f_2013_10				
Comment Code					
BU : Building					
Inspector Comment					
There is a tool shed and fire pit on landward slope and toe.

Looking east at fire pit on landward slope.

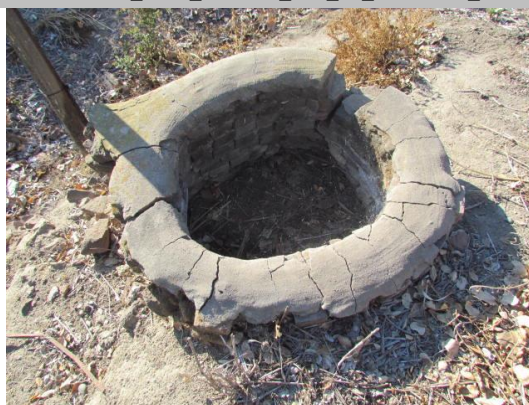
Photo 2 of 3 : SP\_2019\_RD0563\_210\_10\_20190311\_00007.jpg

Looking southeast at fire pit on landward slope.

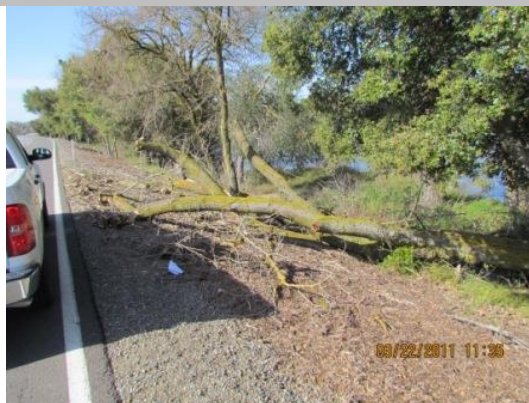
Photo 2 of 2 : SP\_2019\_RD0563\_210\_32\_20190311\_00016.jpg

Looking downstream at fallen tree limb on waterside slope. (Spring 2016)

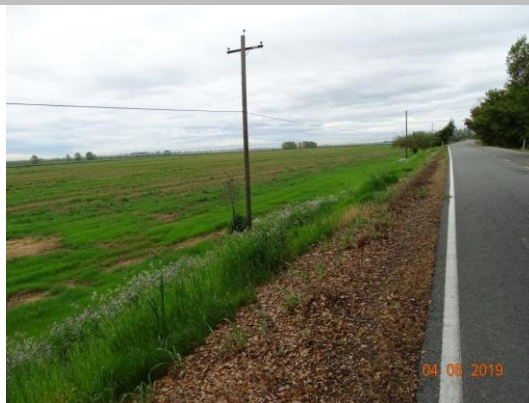
Photo 1 of 1 : SP\_2019\_RD0563\_210\_61\_20190405\_00228.jpg

LM Start	0.23	Rating **	M	Issue No.	61
LM End	0.78	Issue Type +	Ma	Location *	LS
Category	Earthen Levee			GPS Latitude/Longitude	
				Start	End
Item	Vegetation			38.232692 °	38.226420 °
				-121.520014 °	-121.525885 °
DWR ID	DWR_RD0563_01_s_2019_61				
Comment Code					
V1 : Control annual grass and weeds on the levee slopes and easements.					
Inspector Comment

View looking downstream at annual vegetation on the landside slope (Spring 2019).

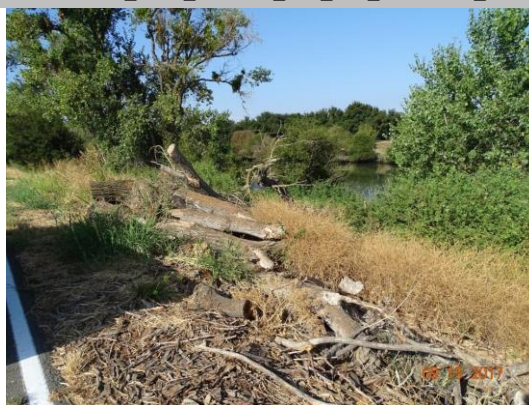
Photo 1 of 1 : SP\_2019\_RD0563\_210\_114\_20190311\_00079.jpg

LM Start	0.40	Rating **	M	Issue No.	114
LM End	0.40	Issue Type +	Ma	Location *	WS
Category	Earthen Levee			GPS Latitude/Longitude	
				Start	End
Item	Encroachments			38.230744 °	38.230744 °
				-121.522022 °	-121.522022 °
DWR ID	DWR_RD0563_01_f_2017_114				
Comment Code					
TR : Tree or limb					
Inspector Comment

Looking southwest at the waterside slope.

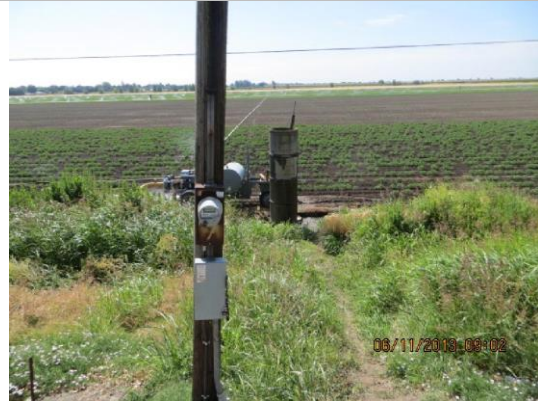
Photo 1 of 3 : UCIP\_SP\_2019\_52741\_24508.jpg

Comment Code						
Inspector Comment						
FS_ID:52741 DS_ID:20130 EP_NO: 11218 Repair Type: Non-Urgent Crossing Status: Found UCIP Comments: 07/13/2018 Electrical conduit that is attached to the pipe on WS fell appart at several locations. LS and WS slopes are heavily vegetated. (O.Yakimov-DWR UCIP)06/11/2013 Pipe leaking at various points on WS berm. Failure on berm may indicate potential for failure within the levee. Good candidate for video inspection. (W.Wylie-DWR) FIELD_STRUCT_DESC: 12-inch steel irrigation pipe through the levee, 5 feet below the crown. Walkway to pump on pile structure in stream. Siphon breaker in a 24-inch corrugated metal pipe (CMP) riser on the waterside (WS) shoulder. 1-inch air and vacuum valve and a 15-foot-tall by 36-inch-diameter concrete standpipe at the landside (LS) toe. (Automatic Board Order (ABO) issued as Permit No. 11218, 1975 - Fong Yock Yee). [Additional Reference(s): DWR Levee Log, 2005. USACE Sacramento O&M Manual 103, June 1954, (Station ""L2"" 196+67.8)]. FS Date: 7/13/2018 9:38:39 AM

JP on LS slope with 36-inch concrete standpip on LS toe.

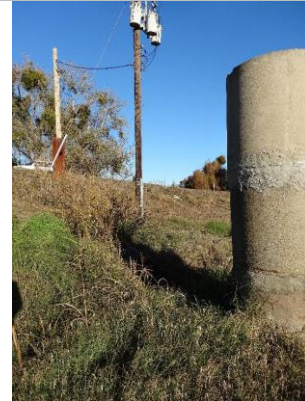
Photo 1 of 3 : UCIP\_SP\_2019\_52731\_76821.jpg

Comment Code					
Inspector Comment					
FS_ID:52731 DS_ID:20131 EP_NO: 11203 Repair Type: Urgent Crossing Status: Found UCIP Comments: 07/13/2018 Dense vegetation on LS slope limits visibility. Crossing remains "Urgent" due to unknown condition of the pipe section through the levee. (O.Yakimov-DWR UCIP) 03/08/2018 LS pipe section replaced however, unable to determine the condition of the pipe section through the levee. LS levee section disburbed and has not been repaired. Crossing remains Urgent due to the unknown condition of the pipe section through the levee. (O. Magana - DWR UCIP)12/02/2016 Same as last inspection signs of leak are still present on both LS and WS. Recommend internal inspection of the pipe integrity though the levee to determine cause of depression on levee (either leak or poor compaction). Pipe debris previous noted on WS has been removed. (O. Magana - DWR UCIP)06/11/2013 Signs of leak in pipe at levee slope on both LS and WS where pipe enters levee. Moist soil at LS toe indicates possible internal leak. Evidence of recent pipe repair on WS. Pipe debris on WS toe should be removed. (W. Wylie - DWR UCIP) FIELD_STRUCT_DESC: 12-inch steel irrigation pipe through the levee, 5 feet below the crown. Slant pump located on the waterside (WS). Siphon breaker and switch box also located on the WS slope. Service pole is located on the landside (LS) slope. (12-inch pipe authorized under Automatic Board Order (ABO) issued as Permit No. 11203, 1971 - Delta Farmers, Inc.) This crossing has been replaced with 6-inch under DSID 25486, as reported by DWR inspector Richard Willoughby during his Spring 2017 inspection. [Additional Reference(s): DWR Levee Log, 2005. USACE Sacramento O&M Manual Unit 103, June 1954 (HLM 0.73)] FS Date: 7/13/2018

View of landside slope.

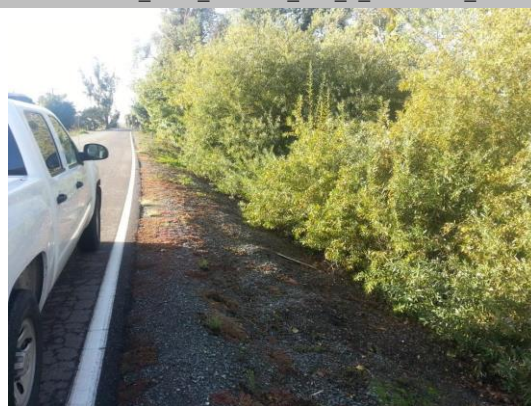
Photo 1 of 2 : SP\_2019\_RD0563\_210\_3\_20190311\_00001.jpg

Looking east at untrimmed trees on waterward slope. (Fall 2016)

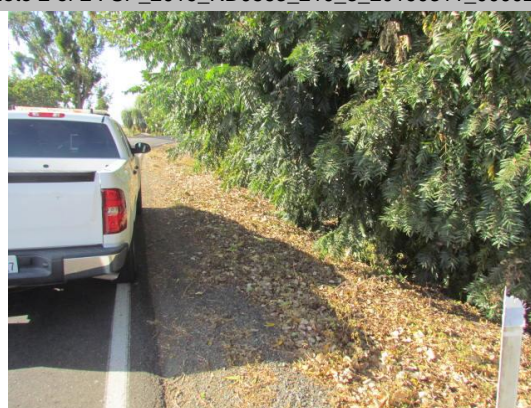
Photo 2 of 2 : SP\_2019\_RD0563\_210\_3\_20190311\_00002.jpg

Looking east at untrimmed trees on waterward slope and toe. (Spring 2016)

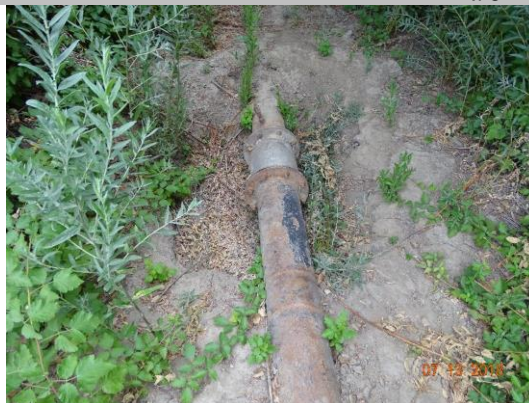
Photo 2 of 3 : UCIP\_SP\_2019\_52744\_77723.jpg

New pipe and old pipe connection on WS.

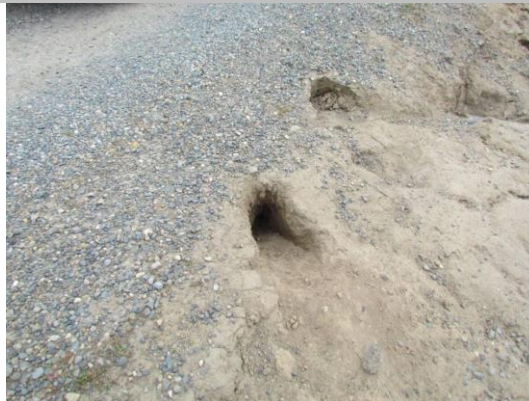
Photo 1 of 2 : SP\_2019\_RD0563\_210\_121\_20190311\_00084.jpg

LM Start	0.95	Rating **	U	Issue No.	121
LM End	0.95	Issue Type +	Ma	Location *	LS
Category	Earthen Levee			GPS Latitude/Longitude	
				Start	End
Item	Animal Control			38.225808 °	38.225808 °
				-121.528197 °	-121.528197 °
DWR ID	DWR_RD0563_01_s_2017_121				
Comment Code					
A1 : Exterminate rodents and backfill and compact or grout burrows.					
Inspector Comment					
There are several large rodent holes on the landward slope.

Looking at typical rodent hole at this location.

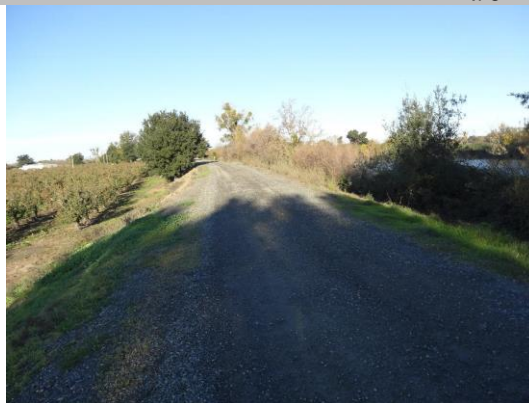
Photo 1 of 3 : UCIP\_SP\_2019\_52745\_76827.jpg

View of levee crown at pipe crossing.

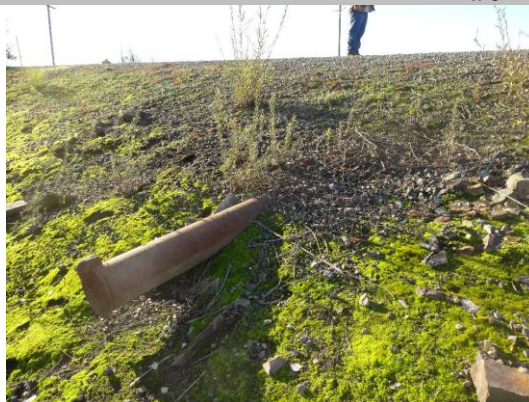
Photo 2 of 3 : UCIP\_SP\_2019\_52745\_76828.jpg

Pipe with flap visible on WS.

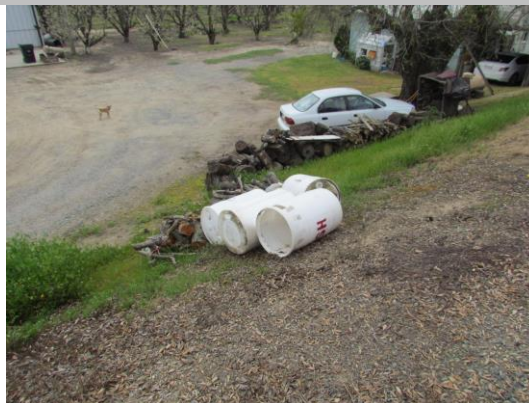
Photo 1 of 2 : SP\_2019\_RD0563\_210\_134\_20190311\_00096.jpg

LM Start	1.21	Rating **	M	Issue No.	134
LM End	1.21	Issue Type +	En	Location *	LS
Category	Earthen Levee			GPS Latitude/Longitude	
				Start	End
Item	Encroachments			38.226462 °	38.226462 °
				-121.532172 °	-121.532172 °
DWR ID	DWR_RD0563_01_s_2016_134				
Comment Code					
FW : Firewood					
Inspector Comment					
Landowner is stock piling firewood and other garbage at the landward toe.

Looking east at firewood and empty containers on landward slope. (Spring 2017)

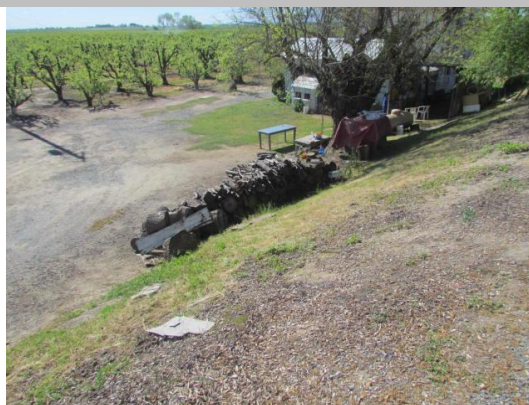
Photo 2 of 2 : SP\_2019\_RD0563\_210\_134\_20190311\_00097.jpg

Looking southeast at firewood at landward toe. (Spring 2016)

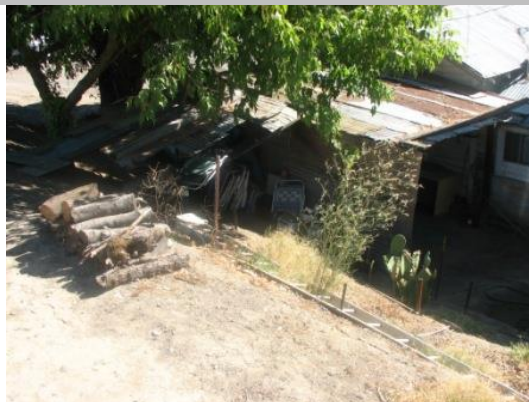
Photo 2 of 2 : SP\_2019\_RD0563\_210\_57\_20190311\_00021.jpg

Looking at a shed at landside toe.

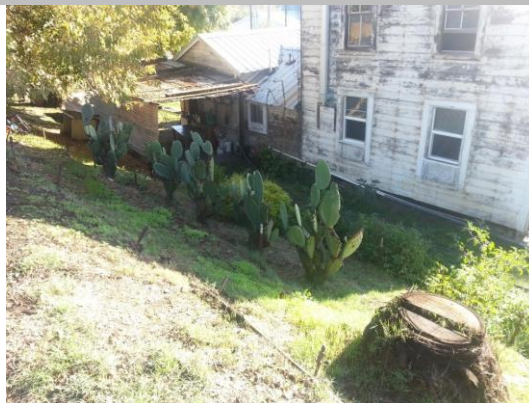
Photo 1 of 2 : SP\_2019\_RD0563\_210\_170\_20190311\_00117.jpg

LM Start	1.22	Rating **	M	Issue No.	170
LM End	1.24	Issue Type +	En	Location *	LS
Category	Earthen Levee			GPS Latitude/Longitude	
				Start	End
Item	Vegetation			38.226316 °	38.226053 °
				-121.532342 °	-121.532525 °
DWR ID	DWR_RD0563_01_f_2016_170				
Comment Code					
V6 : Landscaping					
Inspector Comment					
Remove cactus on landward slope.

Looking southeast at cactus on landward slope.

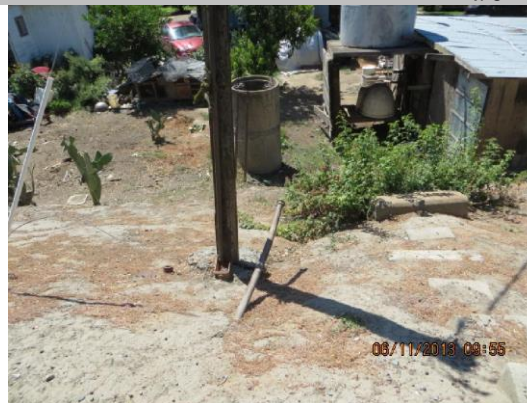
Photo 1 of 3 : UCIP\_SP\_2019\_52747\_24527.jpg

LM Start	1.40	Rating **	M	Issue No.	777
LM End	1.40	Issue Type +	En	Location *	
Category	Supplemental			GPS Latitude/Longitude	
				Start	End
Item	DWR UCIP Field Study			38.224302 °	38.224302 °
				-121.534287 °	-121.534287 °
DWR ID	20134				
Comment Code					
Inspector Comment					
FS_ID:52747 DS_ID:20134 EP_NO: N/A Repair Type: Non-Urgent Crossing Status: Found UCIP Comments: 07/13/2018 Same as last inspection. (O.Yakimov-DWR UCIP)06/11/2013 Pipe open on LS and should be removed. FIELD_STRUCT_DESC: *ABANDONED* 2-inch electrical conduit of an unknown material through the levee, 2 feet below the crown. [Additional Reference(s): DWR Levee Log, 2005]. FS Date: 7/13/2018 2:34:56 PM

Pipe visible on LS slope at JP.

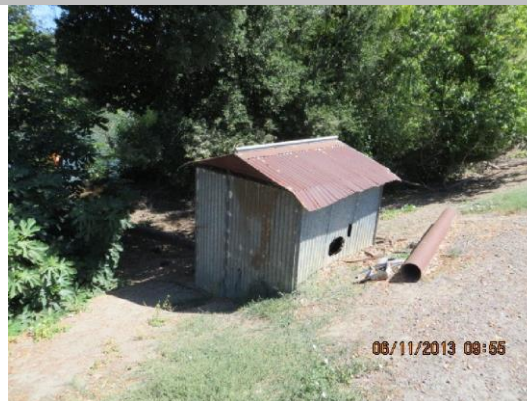
Photo 2 of 3 : UCIP\_SP\_2019\_52747\_24526.jpg

Pipe goes to pumphouse on WS slope.

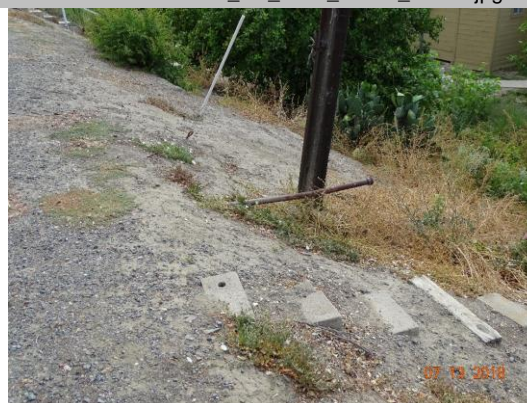
Photo 3 of 3 : UCIP\_SP\_2019\_52747\_77727.jpg

LM Start	1.40	Rating **	M	Issue No.	777 (cont)	
LM End	1.40	Issue Type +	En	Location *		
Category	Supplemental			GPS Latitude/Longitude		
				Start	End	
Item	DWR UCIP Field Study			38.224302 °	38.224302 °	
				-121.534287 °	-121.534287 °	
DWR ID	20134					
Comment Code						
Inspector Comment						
FS_ID:52747 DS_ID:20134 EP_NO: N/A Repair Type: Non-Urgent Crossing Status: Found UCIP Comments: 07/13/2018 Same as last inspection. (O.Yakimov-DWR UCIP)06/11/2013 Pipe open on LS and should be removed. FIELD_STRUCT_DESC: *ABANDONED* 2-inch electrical conduit of an unknown material through the levee, 2 feet below the crown. [Additional Reference(s): DWR Levee Log, 2005]. FS Date: 7/13/2018 2:34:56 PM

View of pipe on LS slope.

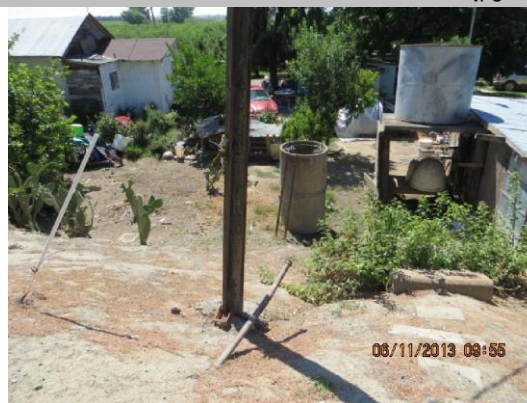
Photo 1 of 3 : UCIP\_SP\_2019\_52748\_24530.jpg

Comment Code					
Inspector Comment					
FS_ID:52748 DS_ID:20189 EP_NO: N/A Repair Type: Non-Urgent Crossing Status: Found UCIP Comments: 07/13/2018 Cut-off, abandoned pipe found on riverbank and WS slope next to the irrigation pipe. Old pipe needs to be properly abandoned. (O.Yakimov-DWR UCIP) FIELD_STRUCT_DESC: 8-inch steel irrigation pipe through the levee, 3.1 feet below the crown. 9-foot-tall by 36-inch-diameter concrete standpipe on the landside (LS) toe. 6-foot by 6-foot corrugated metal pump house with pump and butterfly valve on the waterside (WS). 1- inch galvanized iron electrical conduit through the levee at the same location, at an unknown depth. [Additional Reference(s): USACE Sacramento O&M Manual 103, June 1954, (Station ""L2"" 146+62.8)]. FS Date: 7/13/2018 2:47:32 PM

36-inch concrete standpipe on LS toe.

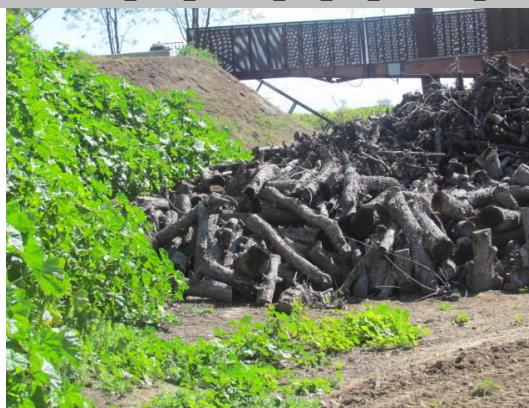
Photo 1 of 1 : SP\_2019\_RD0563\_210\_161\_20190311\_00115.jpg

LM Start	1.82	Rating **	M	Issue No.	161
LM End	1.82	Issue Type +	En	Location *	LS
Category	Earthen Levee			GPS Latitude/Longitude	
				Start	End
Item	Encroachments			38.222768 °	38.222768 °
				-121.541837 °	-121.541837 °
DWR ID	DWR_RD0563_01_f_2018_161				
Comment Code					
FW : Firewood					
Inspector Comment					
Landowner is stocking firewood at the landside toe.

Looking north at fireward at landward toe.

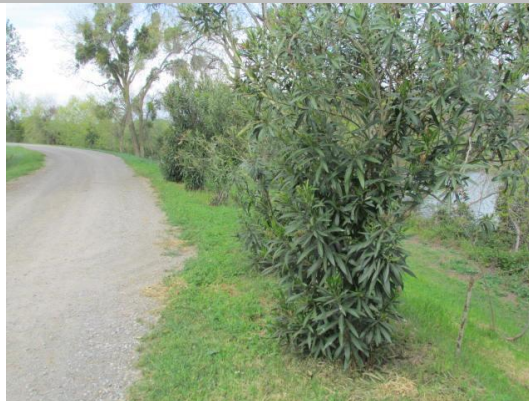
Photo 2 of 2 : SP\_2019\_RD0563\_210\_142\_20190311\_00103.jpg

LM Start	1.86	Rating **	M	Issue No.	142 (cont)	
LM End	1.87	Issue Type +	En	Location *	WS	
Category	Earthen Levee			GPS Latitude/Longitude		
				Start		End
Item	Vegetation			38.222743 °		38.222720 °
				-121.542523 °		-121.542741 °
DWR ID	DWR_RD0563_01_s_2014_142					
Comment Code						
V6 : Landscaping						
Inspector Comment						
Landowner has planted oleanders on the waterside shoulder.

Looking southwest at oleanders on waterward shoulder.

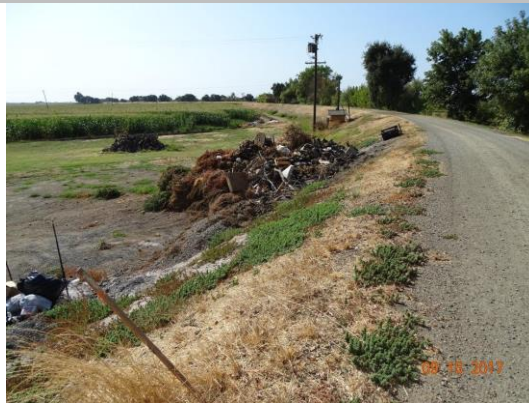
Photo 1 of 1 : SP\_2019\_RD0563\_210\_157\_20190311\_00114.jpg

LM Start	1.94	Rating **	U	Issue No.	157
LM End	1.94	Issue Type +	En	Location *	LS
Category	Earthen Levee			GPS Latitude/Longitude	
				Start	End
Item	Encroachments			38.222080 °	38.222080 °
				-121.543445 °	-121.543445 °
DWR ID	DWR_RD0563_01_f_2015_157				
Comment Code					
GA : Garbage					
Inspector Comment					
Landowner is stockpiling garbage at the landside toe.

Looking south at the garbage on the landside toe.

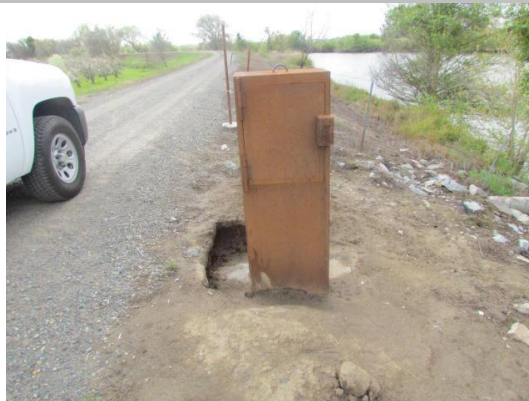
Photo 1 of 1 : SP\_2019\_RD0563\_210\_15\_20190311\_00009.jpg

LM Start	2.18	Rating **	M	Issue No.	15
LM End	2.18	Issue Type +	En	Location *	WS
Category	Earthen Levee			GPS Latitude/Longitude	
				Start	End
Item	Encroachments			38.218575 °	38.218575 °
				-121.542668 °	-121.542668 °
DWR ID	DWR_RD0563_01_s_2012_15				
Comment Code					
EQ : Equipment					
Inspector Comment					
Landowner installed a metal box around siphon breaker.

Looking south at siphon box installed on waterside shoulder.

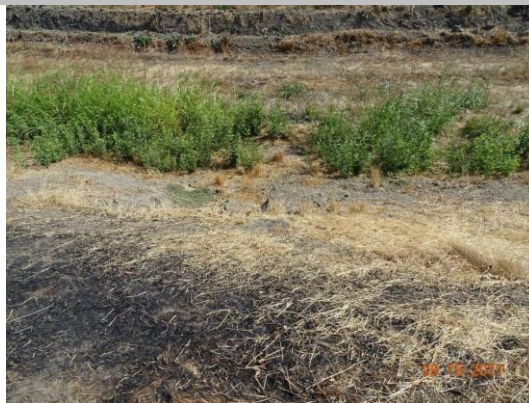
Photo 1 of 1 : SP\_2019\_RD0563\_210\_116\_20190311\_00080.jpg

LM Start	2.25	Rating **	A/W	Issue No.	116
LM End	2.25	Issue Type +	Ma	Location *	LS
Category	Earthen Levee			GPS Latitude/Longitude	
				Start	End
Item	Erosion / Bank Caving			38.217588 °	38.217588 °
				-121.542520 °	-121.542520 °
DWR ID	DWR_RD0563_01_s_2017_116				
Comment Code					
E2 : Schedule repair of erosion site prior to the next inspection.					
Inspector Comment					
LMA found the erosion while on patrol during the February Storm 2017.

Looking east at the landside toe erosion.

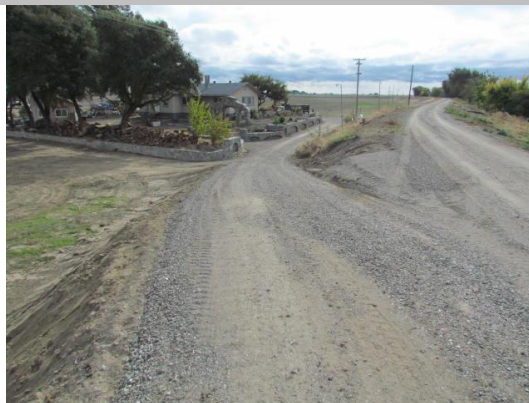
Photo 2 of 2 : SP\_2019\_RD0563\_210\_80\_20190311\_00051.jpg

LM Start	2.57	Rating **	M	Issue No.	80 (cont)	
LM End	2.57	Issue Type +	En	Location *	LS	
Category	Earthen Levee			GPS Latitude/Longitude		
				Start		End
Item	Encroachments			38.214707 °		38.214707 °
				-121.538061 °		-121.538061 °
DWR ID	DWR_RD0563_01_f_2012_80					
Comment Code						
RA : Ramp						
Inspector Comment						
Landowner installed unauthorized ramp on landside slope. This ramp is not part of permit # 9146.

Looking southeast at unauthorized ramp on landside slope.

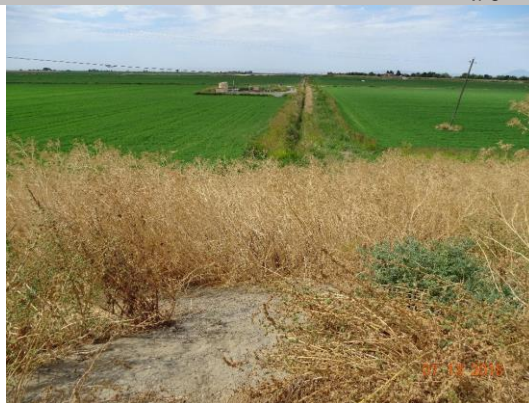
Photo 2 of 3 : UCIP\_SP\_2019\_52754\_77743.jpg

Comment Code					
Inspector Comment					
FS_ID:52754					
DS_ID:20139					
EP_NO: N/A					
Repair Type: Non-Urgent					
Crossing Status: Found					
UCIP Comments: 07/13/2018 Unable to locate siphon breaker and					
CMP riser on LS due to heavy vegetation. (O.Yakimov-DWR					
UCIP)06/11/2013 Abandoned and should be done so properly. Need					
to verify disposition of pipe.					
FIELD_STRUCT_DESC: *ABANDONED* 6-inch steel pipe of an					
unknown purpose through the levee, 4 feet below the crown. Siphon					
breaker in a 24-inch corrugated metal pipe (CMP) riser on the landside					
(LS) shoulder. Open on both ends. [Additional Reference(s): DWR					
Levee Log, 2005. USACE Sacramento O&M Manual 103, June 1954,					
(Station ""L2"" 62+79) 1-inch air valve, brass cock and cover].					
FS Date: 7/13/2018 9:42:58 AM

Vegetation on LS.

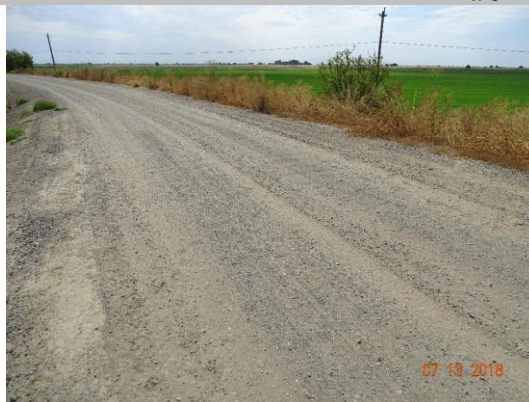
Photo 3 of 3 : UCIP\_SP\_2019\_52754\_77744.jpg

LM Start	<b>3.00</b>	Rating **	M	Issue No.	<b>782 (cont)</b>
LM End	<b>3.00</b>	Issue Type +	En	Location *

View of levee crown at the crossing.

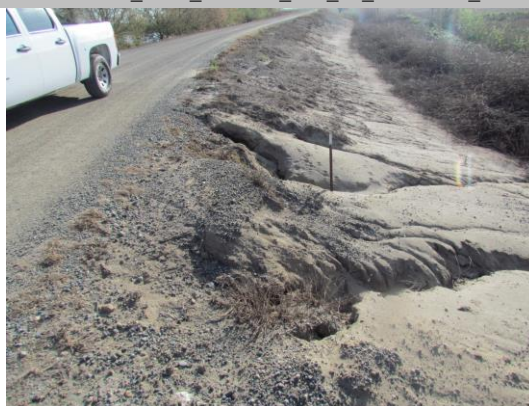
Photo 2 of 5 : SP\_2019\_RD0563\_210\_78\_20190311\_00046.jpg

LM Start	<b>3.06</b>	Rating **	U	Issue No.	<b>78 (cont)</b>
LM End	<b>3.06</b>	Issue Type +	Ma	Location *	LS

Looking north at rain runoff erosion on landward slope. (Spring 2017)

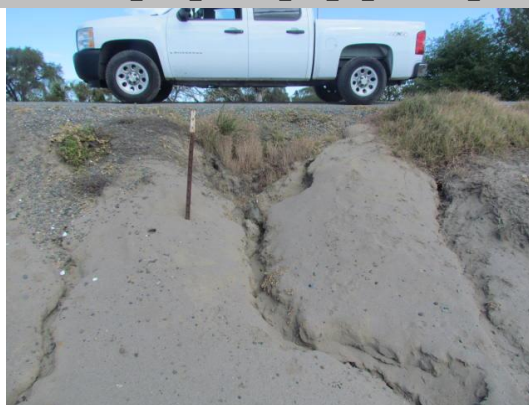
Photo 3 of 5 : SP\_2019\_RD0563\_210\_78\_20190311\_00047.jpg

Looking west at rain runoff erosion on landward slope. (Spring 2016)

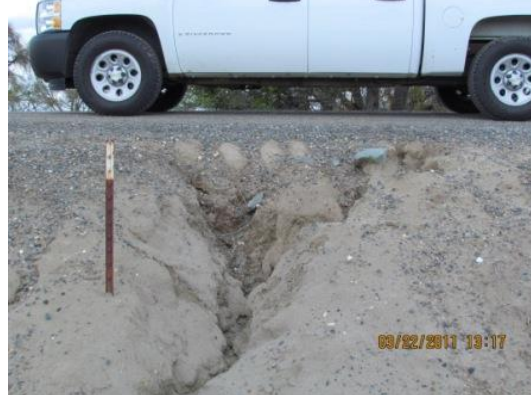
Photo 5 of 5 : SP\_2019\_RD0563\_210\_78\_20190311\_00049.jpg

LM Start	3.06	Rating **	U	Issue No.	78 (cont)	
LM End	3.06	Issue Type +	Ma	Location *	LS	
Category	Earthen Levee			GPS Latitude/Longitude		
				Start		End
Item	Slope Stability			38.210240 °		38.210240 °
				-121.537517 °		-121.537517 °
DWR ID	DWR_RD0563_01_s_2012_78					
Comment Code						
S1 : Repair slope instability.						
Inspector Comment						
Slope damage on landside shoulder and slope has been in place for several inspection cycles. Proper drainage should be provided to prevent further erosion, and erosion should be repaired.

Looking west at slope erosion cause by runoff on landside slope.

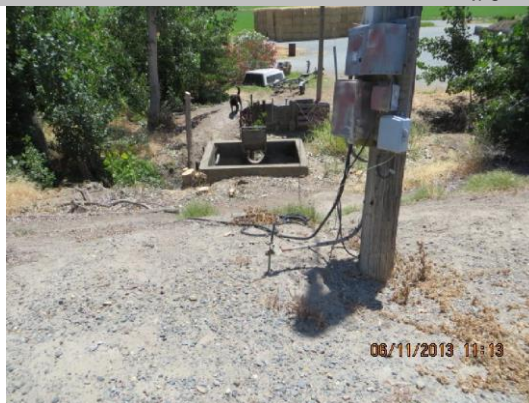
Photo 1 of 3 : UCIP\_SP\_2019\_52755\_24550.jpg

Comment Code						
Inspector Comment						
FS_ID:52755 DS_ID:20140 EP_NO: 12708 Repair Type: Non-Urgent Crossing Status: Found UCIP Comments: 07/13/2018 Pump is running, leak detected on intake pipe hanging down the pumping platform toward the slough. (O.Yakimov-DWR UCIP)06/11/2013 Pipe heavily corroded. Good candidate for viewo inspection. FIELD_STRUCT_DESC: 1 of 2: 14-inch coated steel irrigation pipe through the levee, 3 feet below the crown. Slant pump and gate valve on the waterside (WS). 9-foot by 7-foot reinforced concrete distribution box on the landside (LS) toe. Service pole on the LS shoulder. (Permit No. 12708, 1979 - George C. Wilson, replaced 8-inch pipe under Permit No. 11211, 1975 - Erma E. Locke). [Additional Reference(s): DWR Levee Log, 2005. USACE Sacramento O&M Manual 103, June 1954]. FS Date: 7/13/2018 10:26:03 AM

Distribution box and JP on LS.

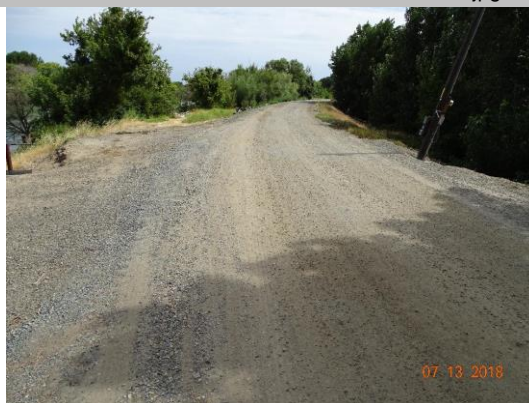
Photo 3 of 3 : UCIP\_SP\_2019\_52755\_77745.jpg

View of levee crown at the crossing.

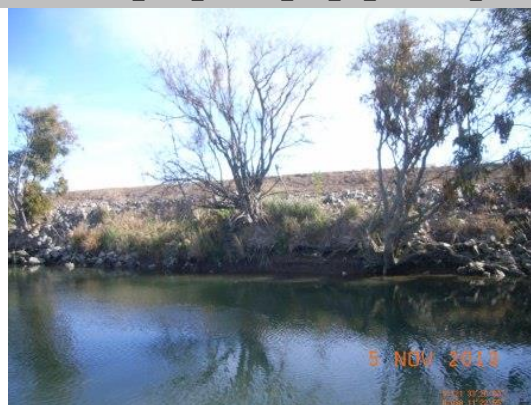
Photo 1 of 1 : SP\_2019\_RD0563\_210\_94\_20190311\_00065.jpg

LM Start	3.42	Rating **	M	Issue No.	94
LM End	4.01	Issue Type +	Ma	Location *	WS
Category	Supplemental			GPS Latitude/Longitude	
				Start	End
Item	2017 USACE Erosion Survey, DRAFT			38.206346 °	38.199925 °
				-121.540819 °	-121.544249 °
DWR ID	DWR_RD0563_01_f _ 2018_94				
Comment Code					
Inspector Comment					
2017 Site ID: GEO 8.3 L					
Status: Eroding					
2017 Field Notes: New rock on levee in sections, failure of old rock in other sections, site extended upstream to account for new erosion pocket.					
Site History: 1997 - Narrow eroding berm upstream of existing rock.					
2001 - Staked, low fascine walls at bankline. 2011 - Minor new erosion. Site extended downstream. 2012 - Rock repair failing in one erosion pocket. 2016 - Fresh erosion observed.

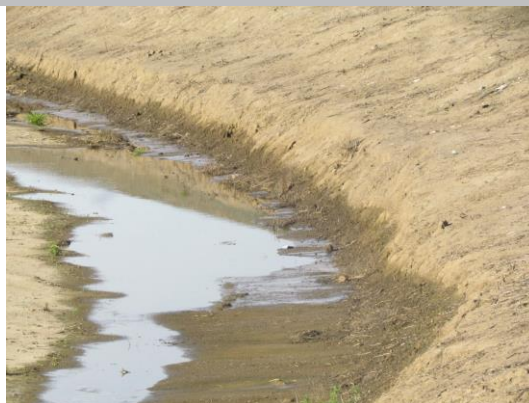
Photo 3 of 4 : SP\_2019\_RD0563\_210\_125\_20190311\_00092.jpg

Looking south at cut along farm's service road at landward toe.

LM Start	3.90	Rating **	M	Issue No.	125 (cont)	
LM End	4.24	Issue Type +	En	Location *	LS	
Category	Earthen Levee			GPS Latitude/Longitude		
				Start		End
Item	Encroachments			38.200627 °		38.197060 °
				-121.542282 °		-121.546190 °
DWR ID	DWR_RD0563_01_s_2017_125					
Comment Code						
AT : Agricultural tilling						
Inspector Comment						
There is a six to twelve inch cut along the landside toe.

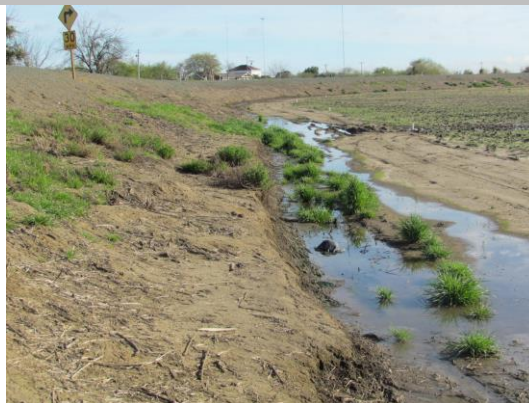
Photo 4 of 4 : SP\_2019\_RD0563\_210\_125\_20190311\_00093.jpg

Looking northwest at cut along farm's service road at landward toe.

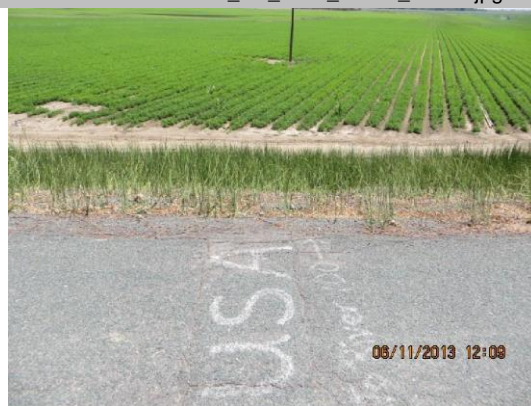
Photo 2 of 3 : UCIP\_SP\_2019\_52758\_27389.jpg

Comment Code						
Inspector Comment						
FS_ID:52758 DS_ID:23971 EP_NO: N/A Repair Type: Non-Urgent Crossing Status: Found UCIP Comments: 07/13/2018 Cut-off abandoned, and silted pipe is visible at WS toe. Need a confirmation that pipe through levee was removed. (O.Yakimov-DWR UCIP)06/11/2013 Need to determine disposition of pipe. Likely that this pipe was removed from levee section as evidenced by the cut in pavement on crown. (W.Wylie) FIELD_STRUCT_DESC: 4.5-inch gas line of an unknown material through the levee, at an unknown depth. Cut in pavement and pipe visible on the waterside (WS) toe. (Permit No. 15539 - Pacific Gas and Electric Company [PG&E] [date not indicated in permit]). FS Date: 7/13/2018

Cut in pavement with USAA markings for gasline.

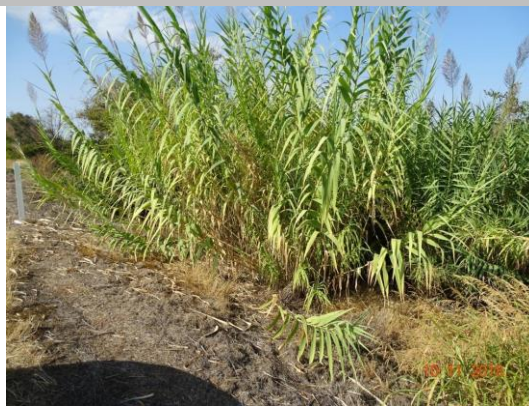
Photo 1 of 1 : SP\_2019\_RD0563\_210\_146\_20190311\_00107.jpg

LM Start	4.52	Rating **	M	Issue No.	146
LM End	4.52	Issue Type +	Ma	Location *	WS
Category	Earthen Levee			GPS Latitude/Longitude	
				Start	End
Item	Vegetation			38.194090 °	38.194090 °
				-121.549568 °	-121.549568 °
DWR ID	DWR_RD0563_01_f_2018_146				
Comment Code					
V2 : Remove the wild growth other than native grasses from the levee slopes.					
Inspector Comment					
Remove arundo.

View of arundo on waterside slope (October 2018).

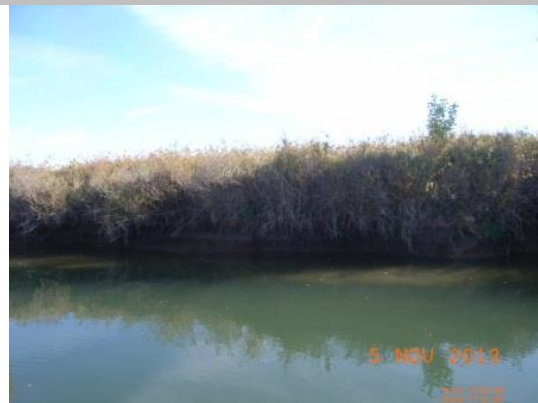
Photo 1 of 1 : SP\_2019\_RD0563\_210\_92\_20190311\_00063.jpg

LM Start	4.98	Rating **	M	Issue No.	92
LM End	5.04	Issue Type +	Ma	Location *	WS
Category	Supplemental			GPS Latitude/Longitude	
				Start	End
Item	2017 USACE Erosion Survey, DRAFT			38.190073 °	38.189524 °
				-121.556307 °	-121.557227 °
DWR ID	DWR_RD0563_01_f_2018_92				
Comment Code					
Inspector Comment					
2017 Site ID: GEO 7.2 L					
Status: Eroding					
2017 Field Notes: New erosion at toe.					
Site History: 2009 - Small scallops of erosion into the levee toe behind brush boxes. 2011 - Minor new erosion. 2012 - Site extended upstream to account for addition erosion pockets. 2016 - Fresh erosion observed.

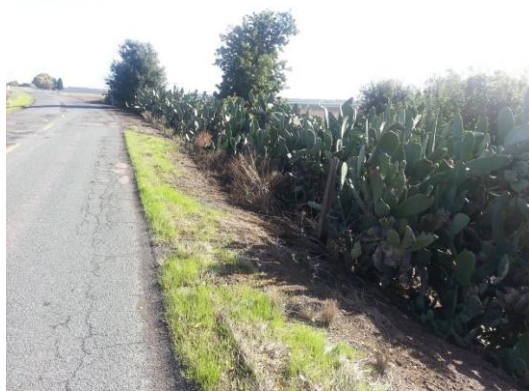
Photo 1 of 1 : SP\_2019\_RD0563\_210\_22\_20190311\_00011.jpg

LM Start	5.92	Rating **	U	Issue No.	22
LM End	5.96	Issue Type +	Ma	Location *	LS
Category	Earthen Levee			GPS Latitude/Longitude	
				Start	End
Item	Vegetation			38.181965 °	38.181763 °
				-121.569913 °	-121.570447 °
DWR ID	DWR_RD0563_01_s_2012_22				
Comment Code					
V2 : Remove the wild growth other than native grasses from the levee slopes.					
Inspector Comment					
Large cactus on landside slope.

Looking downstream at dense cactus on landward slope. (Fall 2016)

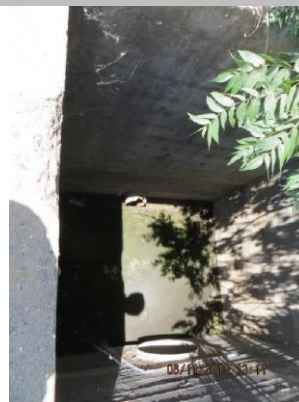
Photo 2 of 3 : UCIP\_SP\_2019\_14950\_24606.jpg

Outlet pipe in distribution box on LS toe.

Comment Code						
Inspector Comment						
FS_ID:14950 DS_ID:20149 EP_NO: 11206 Repair Type: Non-Urgent Crossing Status: Found UCIP Comments: Need to install a CMP riser on LS shoulder to protect the vent/filler pipe. FIELD_STRUCT_DESC: 2 of 2: 10-inch steel irrigation siphon through the levee, 4.8 feet below the crown. Vent/filler pipe on the landside (LS) shoulder. 7-foot by 9-foot concrete distribution box on the LS toe. (Automatic Board Order (ABO) issued as Permit No. 11206, 1975 - Daniel Faustman). [Additional Reference(s): DWR Levee Log, 2005. USACE Sacramento O&M Manual 103, June 1954, (Station ""L"" 324+07.5) 2-inch air and primer valve, reinforced concrete spillbox]. FS Date: 6/11/2013

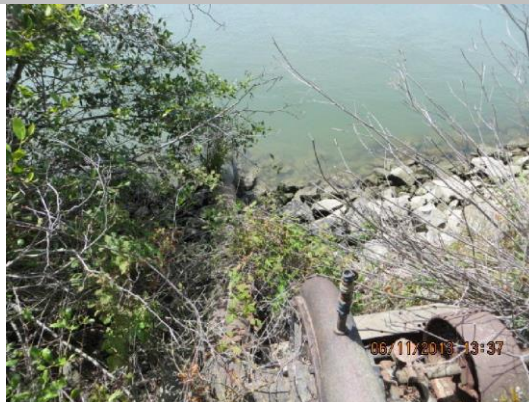
Photo 2 of 3 : UCIP\_SP\_2019\_14966\_24627.jpg

Pump and pipe on WS slope.

Comment Code						
Inspector Comment						
FS_ID:14966 DS_ID:20152 EP_NO: 11201 Repair Type: Non-Urgent Crossing Status: Found UCIP Comments: Appears abandoned and should be done so properly. FIELD_STRUCT_DESC: 3 of 3: 8-inch steel irrigation pipe through the levee, 4.7 feet below the crown. Pump and gate valve on the waterside (WS) berm. 4-foot-diameter concrete standpipe on the landside (LS) toe. Y-ramp on the WS slope. (Automatic Board Order (ABO) issued as Permit No. 11201, 1975 - Joseph Brun). [Additional Reference(s): DWR Levee Log, 2005. USACE Sacramento O&M Manual 103, June 1954, (Station ""L "" 294+25.1)]. FS Date: 6/11/2013

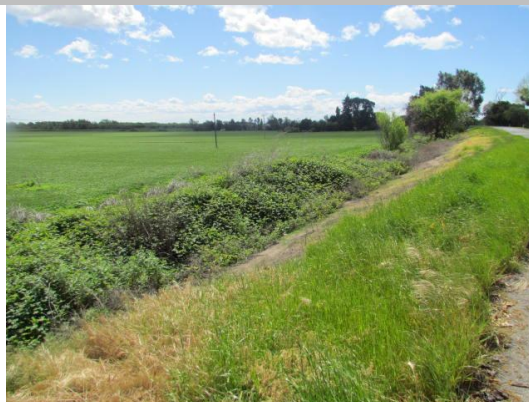
Photo 1 of 1 : SP\_2019\_RD0563\_210\_164\_20190311\_00116.jpg

LM Start	6.59	Rating **	U	Issue No.	164
LM End	6.65	Issue Type +	Ma	Location *	LS
Category	Earthen Levee			GPS Latitude/Longitude	
				Start	End
Item	Vegetation			38.177438 °	38.176647 °
				-121.579151 °	-121.579560 °
DWR ID	DWR_RD0563_01_s_2016_164				
Comment Code					
V2 : Remove the wild growth other than native grasses from the levee slopes.					
Inspector Comment					
Dense vegetation (dead berry vines) at landside toe should be removed.

Looking east at dense vegetation (vines) at landward toe.

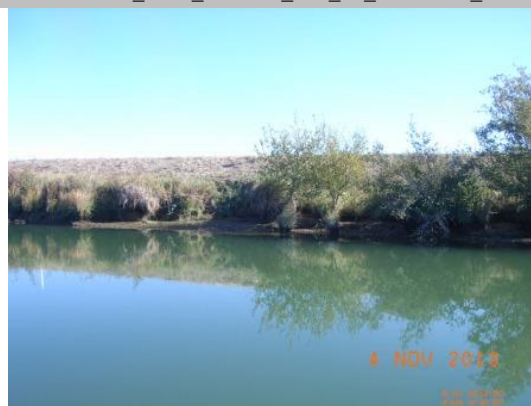
Photo 1 of 1 : SP\_2019\_RD0563\_210\_89\_20190311\_00058.jpg

Comment Code					
Inspector Comment					
2017 Site ID: GEO 5.3 L					
Status: Eroding					
2017 Field Notes: Site extended upstream, increased toe erosion from boat wake/tide action, RD has placed rock on levee slope in places.					
Site History: 1997 - Pocket erosion into the toe of the levee. 2000 - Scallops in banks with small colored flags, biotech rolls present. 2001 - Staked, low fascine walls at bankline. 2003 - Still have visibly bad spots, especially at the upstream end. 2005 - Some new brush bundles in the brush boxes; some with missing bundles. Some boxes too low relative to high tide. 2010 - Site extended upstream. 2011 - Minor new erosion. 2016 - Fresh erosion observed.

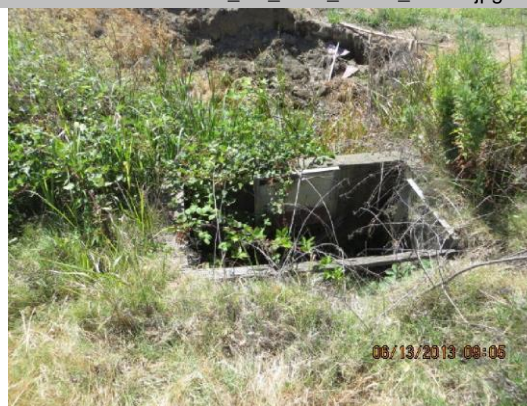
Photo 1 of 3 : UCIP\_SP\_2019\_40790\_24633.jpg

Comment Code					
Inspector Comment					
FS_ID:40790					
DS_ID:20153					
EP_NO: 11202					
Repair Type: Non-Urgent					
Crossing Status: Found					
UCIP Comments: Pipe appears abandoned and if so should be done so properly.					
FIELD_STRUCT_DESC: 12-inch steel irrigation pipe through the levee, 4.5 feet below the crown. Vent/filler pipe in a 24-inch corrugated metal pipe (CMP) riser on the landside (LS) shoulder, and a 7-foot by 9-foot concrete distribution box on the LS toe. (Automatic Board Order (ABO) issued as Permit No. 11202, 1975 - Peter L. and Marian M. Campi).					
[Additional Reference(s): DWR Levee Log, 2005. USACE Sacramento O&M Manual 103, June 1954, (Station ""L"" 289+22.9)].					
FS Date: 6/11/2013

7'X9' concrete distribution box on LS toe.

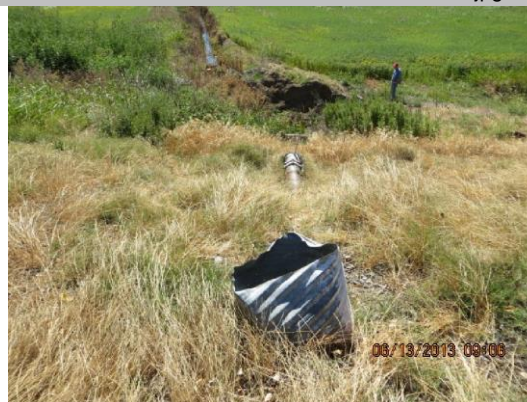
Photo 2 of 3 : UCIP\_SP\_2019\_40790\_24632.jpg

24-inch CMP standpipe with vent/filler pipe on LS shoulder.

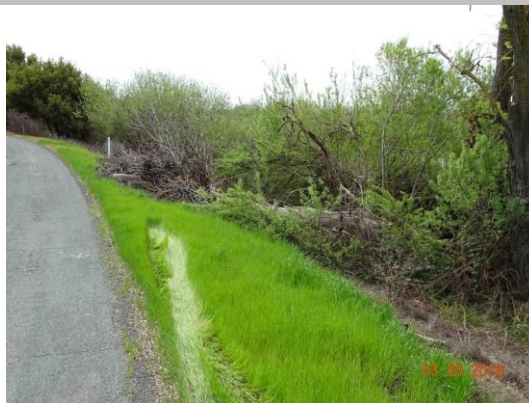
Photo 1 of 1 : SP\_2019\_RD0563\_210\_93\_20190311\_00064.jpg

LM Start	6.74	Rating **	U	Issue No.	93
LM End	6.74	Issue Type +	Ma	Location *	WS
Category	Earthen Levee			GPS Latitude/Longitude	
				Start	End
Item	Encroachments			38.175352 °	38.175352 °
				-121.580177 °	-121.580177 °
DWR ID	DWR_RD0563_01_s_2018_93				
Comment Code					
TR : Tree or limb					
Inspector Comment					
Large fallen tree should be removed from waterside slope and shoulder.

Remove fallen tree from levee slope.

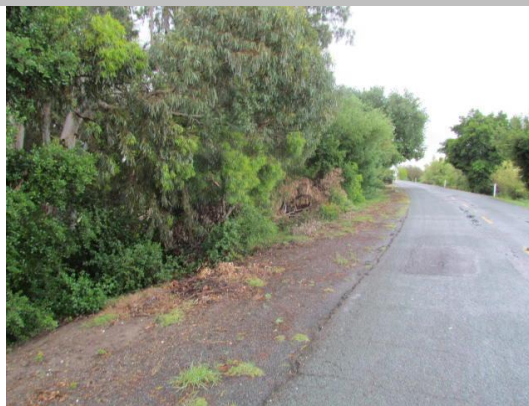
Photo 1 of 1 : SP\_2019\_RD0563\_210\_145\_20190311\_00106.jpg

LM Start	6.75	Rating **	U	Issue No.	145
LM End	6.79	Issue Type +	En	Location *	LS
Category	Earthen Levee			GPS Latitude/Longitude	
				Start	End
Item	Vegetation			38.175219 °	38.174743 °
				-121.580053 °	-121.580016 °
DWR ID	DWR_RD0563_01_s_2014_145				
Comment Code					
V6 : Landscaping					
Inspector Comment					
Untrimmed trees blocking view of landside toe.

Looking southeast at dense vegetation on landward slope and toe.

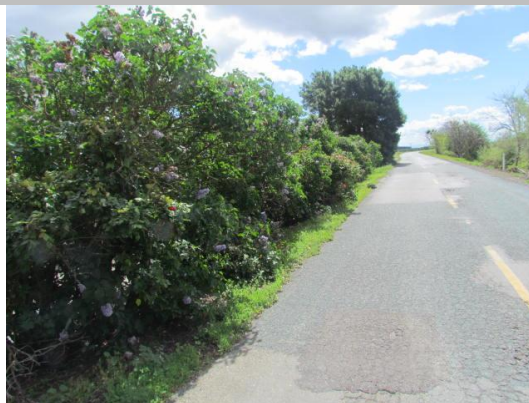
Photo 1 of 1 : SP\_2019\_RD0563\_210\_75\_20190311\_00040.jpg

LM Start	6.80	Rating **	U	Issue No.	75
LM End	6.83	Issue Type +	En	Location *	LS
Category	Earthen Levee			GPS Latitude/Longitude	
				Start	End
Item	Vegetation			38.174598 °	38.174125 °
				-121.579972 °	-121.579892 °
DWR ID	DWR_RD0563_01_s_2013_75				
Comment Code					
V6 : Landscaping					
Inspector Comment					
There is dense landscaping on the landside shoulder, slope, and toe.

Looking south at dense landscaping on landward shoulder and slope.  
(Spring 2016)

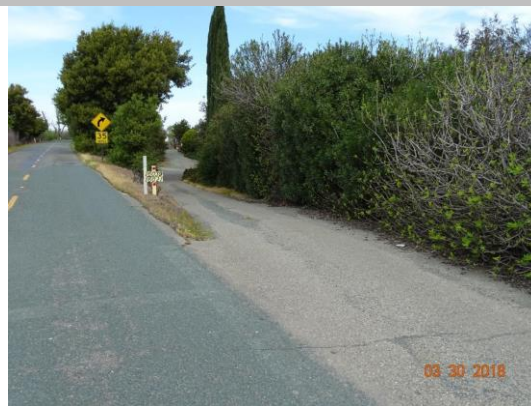
Photo 1 of 1 : SP\_2019\_RD0563\_210\_119\_20190311\_00082.jpg

LM Start	6.84	Rating **	U	Issue No.	119
LM End	6.87	Issue Type +	En	Location *	LS
Category	Earthen Levee			GPS Latitude/Longitude	
				Start	End
Item	Vegetation			38.173912 °	38.173523 °
				-121.579838 °	-121.579737 °
DWR ID	DWR_RD0563_01_s_2018_119				
Comment Code					
V6 : Landscaping					
Inspector Comment					
Thick landscaping prohibits inspection and access.

Thick landside landscaping preventing inspection and access.

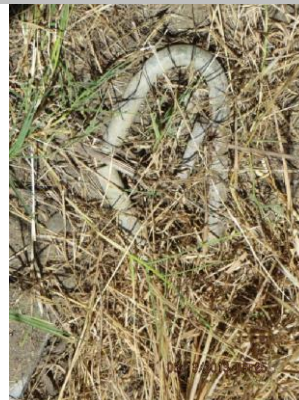
Photo 2 of 3 : UCIP\_SP\_2019\_14968\_24636.jpg

Comment Code						
Inspector Comment						
FS_ID:14968 DS_ID:20154 EP_NO: 11214 Repair Type: Non-Urgent Crossing Status: Indicator Found UCIP Comments: Verify type of abandonment. Wide berm on LS toe with some evidence of steel slide gate in soil at berm. FIELD_STRUCT_DESC: 1 of 2: 8-inch steel irrigation pipe through the levee, 3.7 feet below the crown. Siphon breaker on the waterside (WS) slope. (Automatic Board Order (ABO) issued as Permit No. 11214, 1975 - River Island Land Company). [Additional Reference(s): DWR Levee Log, 2005. USACE Sacramento O&M Manual 103, June 1954, (Station ""L"" 269+36) 1-inch air and primer valve, reinforced concrete spillbox]. FS Date: 6/13/2013

Steel parts on LS toe may indicate location of distribution box.

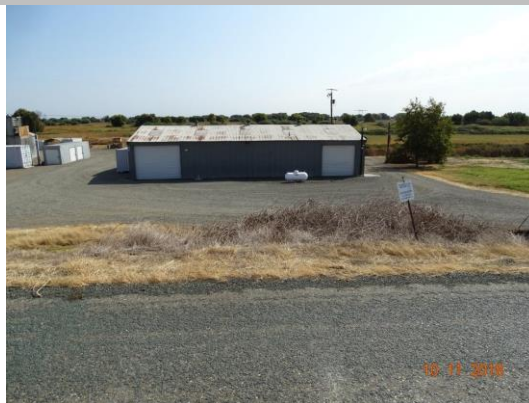
Photo 1 of 1 : SP\_2019\_RD0563\_210\_148\_20190311\_00108.jpg

LM Start	7.14	Rating **	M	Issue No.	148
LM End	7.14	Issue Type +	En	Location *	LS
Category	Earthen Levee			GPS Latitude/Longitude	
				Start	End
Item	Encroachments			38.169717 °	38.169717 °
				-121.580328 °	-121.580328 °
DWR ID	DWR_RD0563_01_f_2018_148				
Comment Code					
DE : Debris					
Inspector Comment					
There are prunings on the landside slope.

View of prunings on landside slope (October 2018).

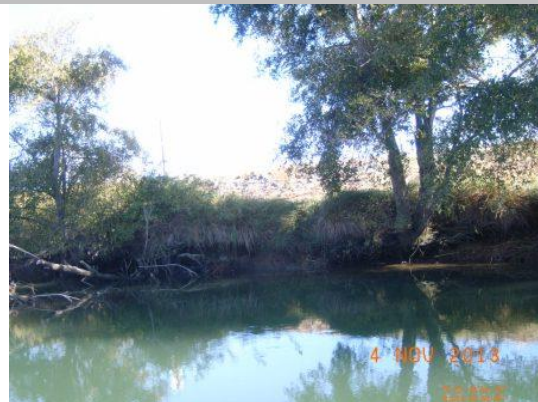
Photo 1 of 1 : SP\_2019\_RD0563\_210\_85\_20190311\_00055.jpg

Comment Code					
Inspector Comment					
2017 Site ID: GEO 4.5 L					
Status: Critical					
2018: Erosion happening at berm, 15 to 20' from the levee hinge point from the berm in some places, erosion into levee toe at other spots (Djulian).					
2017 Field Notes: Numerous areas of bank erosion, with vertical sections up to the levee hinge.					
Site History: 1997 - Pocket erosion at upstream end and into the levee toe under the Alder trees. 2003 - New brush boxes with wattles on bank. 2004 - No brush boxes. 2005 - Site extended from the downstream side of the bridge. Whole bank is vertical. 2010 - Some minor new erosion. 2011 - Site upgraded to CRITICAL. New erosion pockets throughout the site. Sites 4.5, and 4.6 were combined. 2016 - Fresh erosion observed.

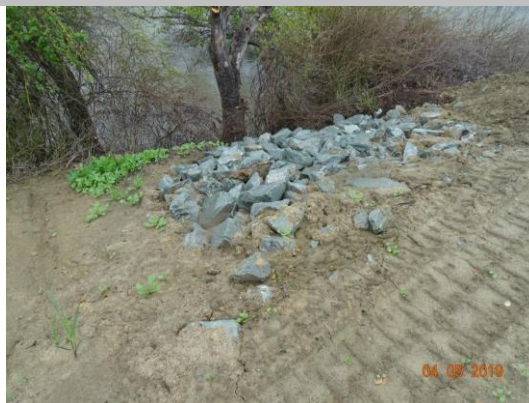
Photo 1 of 1 : SP\_2019\_RD0563\_210\_158\_20190405\_00233.jpg

LM Start	7.71	Rating **	A/W	Issue No.	158
LM End	7.71	Issue Type +	Ma	Location *	WS
Category	Earthen Levee			GPS Latitude/Longitude	
				Start	End
Item	Slope Stability			38.162056 °	38.162056 °
				-121.584043 °	-121.584043 °
DWR ID	DWR_RD0563_01_s_2019_158				
Comment Code					
S1 : Repair slope instability.					
Inspector Comment					
The beaver hole was repaired by the LMA.

View of waterside slope repaired by LMA. A beaver hole was discovered on the waterside slope (Spring 2019).

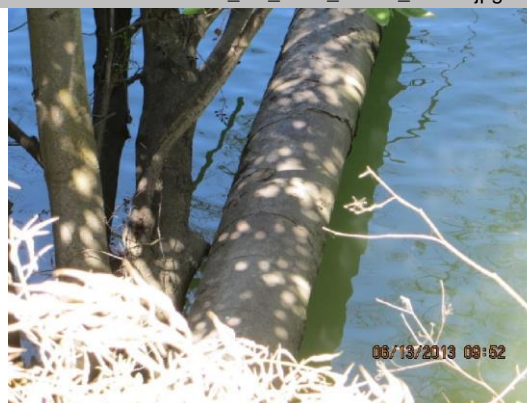
Photo 1 of 2 : UCIP\_SP\_2019\_16304\_27464.jpg

LM Start	7.72	Rating **	M	Issue No.	796
LM End	7.72	Issue Type +	En	Location *	
Category	Supplemental			GPS Latitude/Longitude	
				Start	End
Item	DWR UCIP Field Study			38.161873 °	38.161873 °
				-121.584109 °	-121.584109 °
DWR ID	20185				
Comment Code					
Inspector Comment					
FS_ID:16304					
DS_ID:20185					
EP_NO: N/A					
Repair Type: Non-Urgent					
Crossing Status: Found					
UCIP Comments: Slight depression in crown along pipe alignment may be indication of pipe internal failure. Good candidate for video inspection.					
FIELD_STRUCT_DESC: 14-inch steel irrigation pipe through the levee, 5.1 feet below the crown. [Additional Reference(s): USACE Sacramento O&M Manual 103, June 1954, (Station ""L"" 233+50.5)].					
FS Date: 6/13/2013

Pipe visible on WS toe.

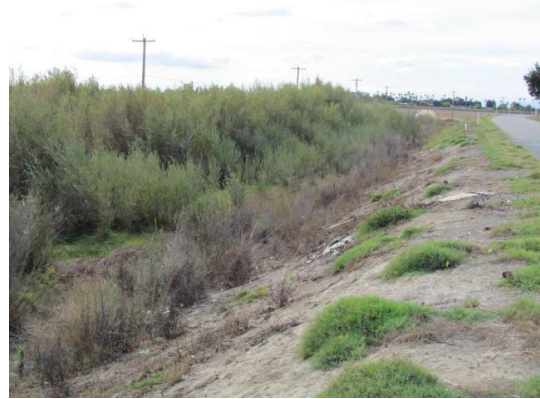
Photo 3 of 3 : SP\_2019\_RD0563\_210\_90\_20190311\_00061.jpg

LM Start	7.80	Rating **	U	Issue No.	90 (cont)	
LM End	7.94	Issue Type +	Ma	Location *	LS	
Category	Earthen Levee			GPS Latitude/Longitude		
				Start	End	
Item	Vegetation			38.160800 °	38.158922 °	
				-121.584598 °	-121.585433 °	
DWR ID	DWR_RD0563_01_s_2012_90					
Comment Code						
V2 : Remove the wild growth other than native grasses from the levee slopes.						
Inspector Comment						
Berry vines and willows are on the landside toe.

Looking south at dense vegetation on landside toe. (2012 Fall Inspection)

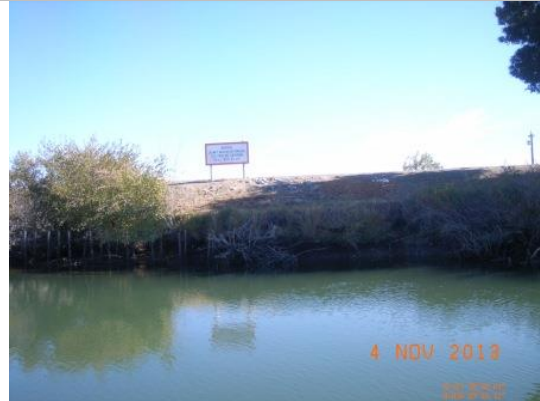
Photo 1 of 1 : SP\_2019\_RD0563\_210\_84\_20190311\_00054.jpg

LM Start	7.85	Rating **	M	Issue No.	84
LM End	8.05	Issue Type +	Ma	Location *	WS
Category	Supplemental			GPS Latitude/Longitude	
				Start	End
Item	2017 USACE Erosion Survey, DRAFT			38.160261 °	38.157625 °
				-121.585056 °	-121.586543 °
DWR ID	DWR_RD0563_01_f_2018_84

Comment Code					
Inspector Comment					
2017 Site ID: GEO 4.3 L					
Status: Eroding					
2017 Field Notes: The worst sections have been filled with quarry stone, but still areas of concern.					
Site History: 1997 - Pockets of erosion into the levee toe. 1999 - Minor rock riprap and willow bundles place in a couple of spots. 2001 - Staked, low fascine walls at bankline. 2003 - Small unprotected pockets still eroding. 2004 - Numerous brush boxes, some falling apart, some with new bundles. 2005 - Some new brush boxes installed; some boxes are empty. Levee slope and banks still look bad with pocket scallops into the levee slopes. 2011 - Erosion continues and the number of pockets is increasing. 2013 - Some of the downstream end was repaired by the RD. 2016 - Fresh erosion observed.

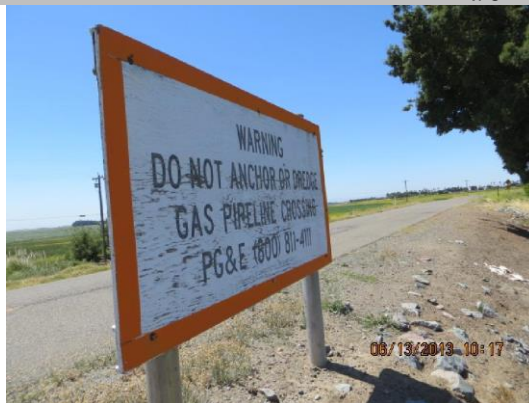
Photo 1 of 2 : UCIP\_SP\_2019\_16263\_27401.jpg

LM Start	7.92	Rating **	M	Issue No.	797	
LM End	7.92	Issue Type +	En	Location *		
Category	Supplemental			GPS Latitude/Longitude		
				Start	End	
Item	DWR UCIP Field Study			38.159207 °	38.159207 °	
				-121.585304 °	-121.585304 °	
DWR ID	23973					
Comment Code						
Inspector Comment						
FS_ID:16263						
DS_ID:23973						
EP_NO: N/A						
Repair Type: Non-Urgent						
Crossing Status: Indicator Found						
UCIP Comments: Need to determine disposition of all gas lines in this immediate area.						
FIELD_STRUCT_DESC: Gas line of an unknown size or material through the levee, at an unknown depth. Gas line marker on the WS shoulder.						
FS Date: 6/13/2013

Sign on WS shoulder.

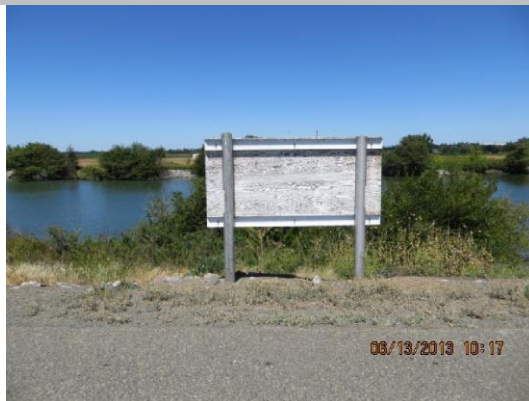
Photo 2 of 2 : UCIP\_SP\_2019\_16263\_27400.jpg

Sign on WS shoulder.

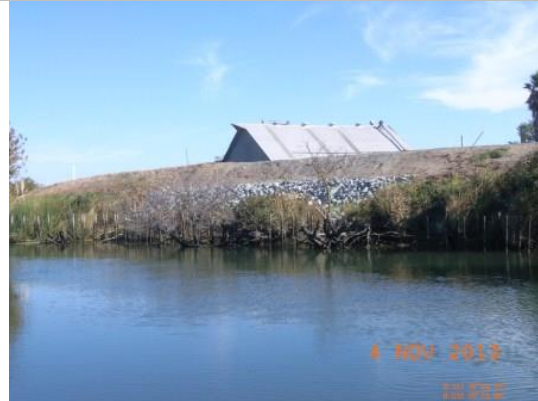
Photo 1 of 1 : SP\_2019\_RD0563\_210\_83\_20190311\_00053.jpg

Comment Code					
Inspector Comment					
2017 Site ID: GEO 3.8 L					
Status: Eroding					
2017 Field Notes: Fresh toe erosion, significant undercutting and slumping.					
Site History: 1997 - Pockets of erosion into the levee at the water line. Alders are being undercut and rotating out into the channel. Damaged rock at upstream end. 2000 - New minor erosion. 2001 - Staked low fascine walls at bankline. 2002 - New "Brush Boxes" along the bank toe. 2003 - New erosion pockets in the middle of the site. 2005 - Some new bundles in the brush boxes. 2011 - Site upgraded to CRITICAL. Significant new erosion. Sites 3.6, 3.7, 3.71, and 4.0 were combined. 2012 - Rock has been placed in some of the erosion pockets since last year, however site remains critical. 2013 - Site no longer critical. The worst pockets were filled with rock by the local RD.

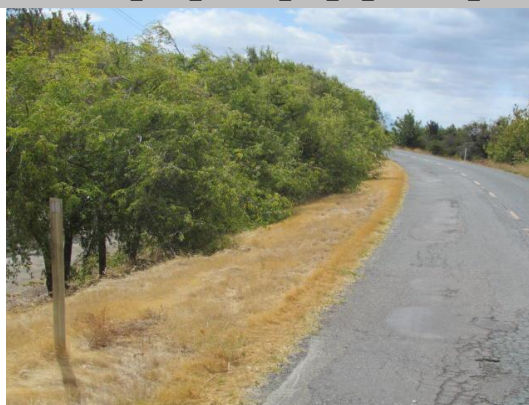
Photo 1 of 1 : SP\_2019\_RD0563\_210\_31\_20190311\_00014.jpg

LM Start	8.38	Rating **	M	Issue No.	31
LM End	8.41	Issue Type +	En	Location *	LS
Category	Earthen Levee			GPS Latitude/Longitude	
				Start	End
Item	Vegetation			38.155974 °	38.155543 °
				-121.591452 °	-121.591595 °
DWR ID	DWR_RD0563_01_s_2012_31				
Comment Code					
V6 : Landscaping					
Inspector Comment

Looking southeast at untrimmed trees on landward slope and toe.
